# ZILKER PARK

## Natural Resource Inventory & Management Guidelines

May 20, 2021

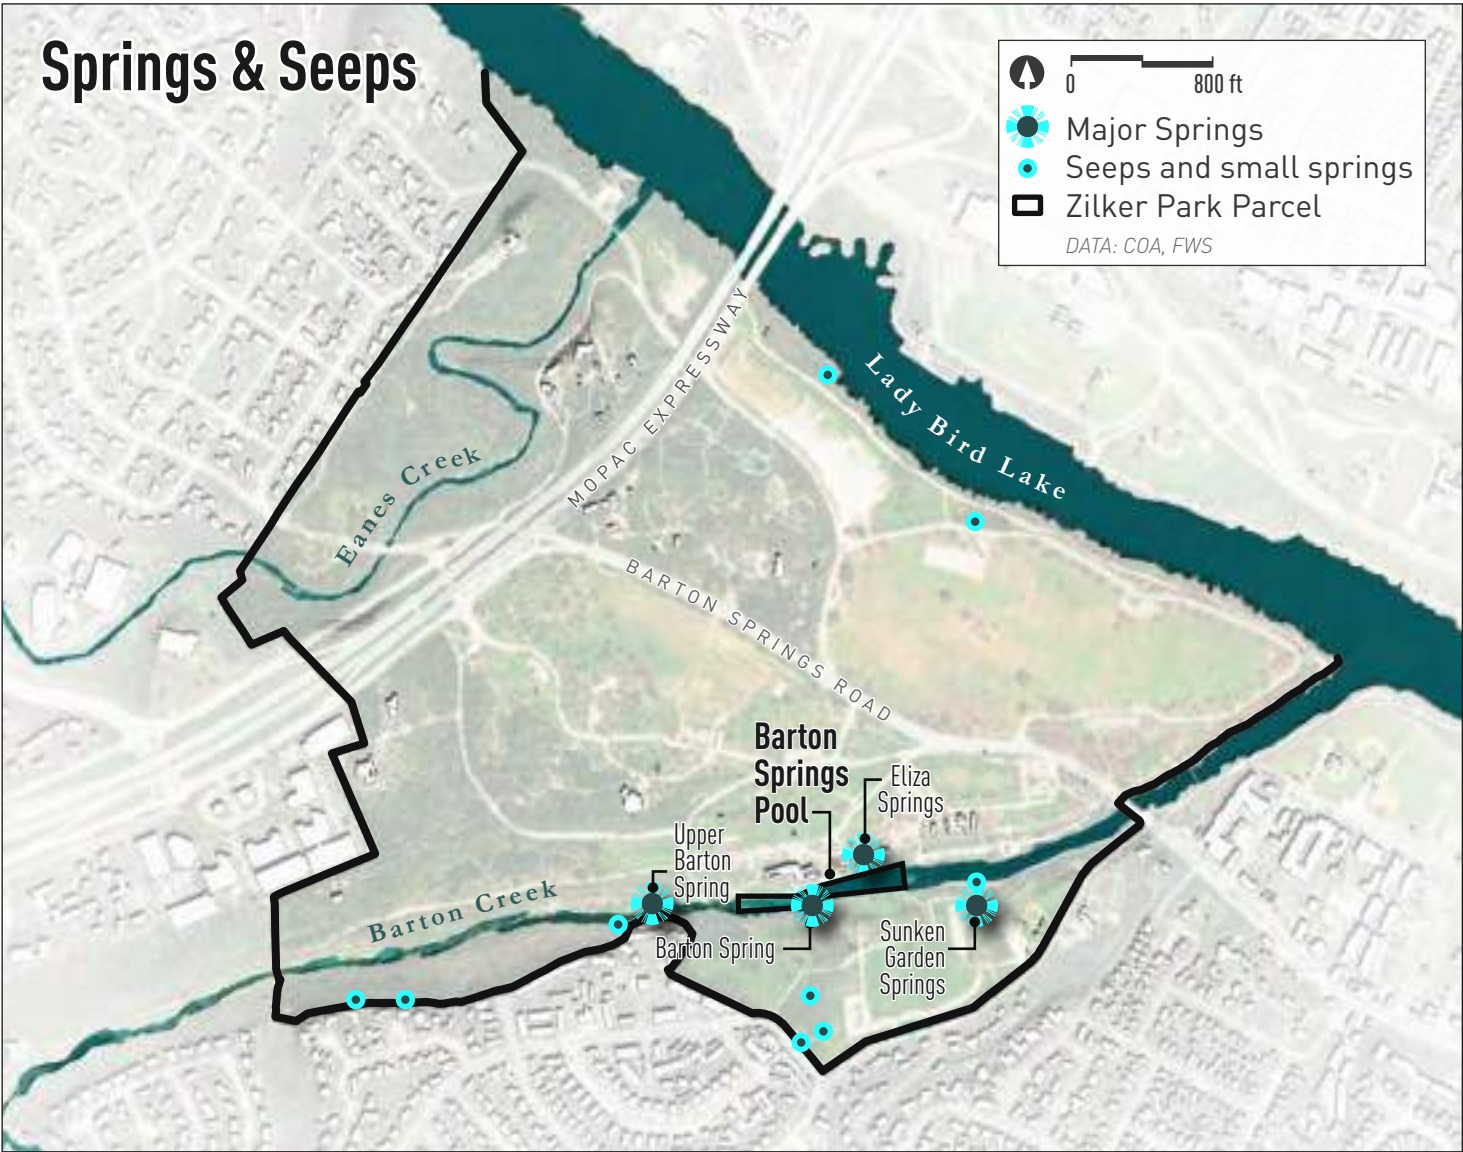
**Figure 3.2.** The seeps and springs of Zilker Park with the 4 major springs highlighted

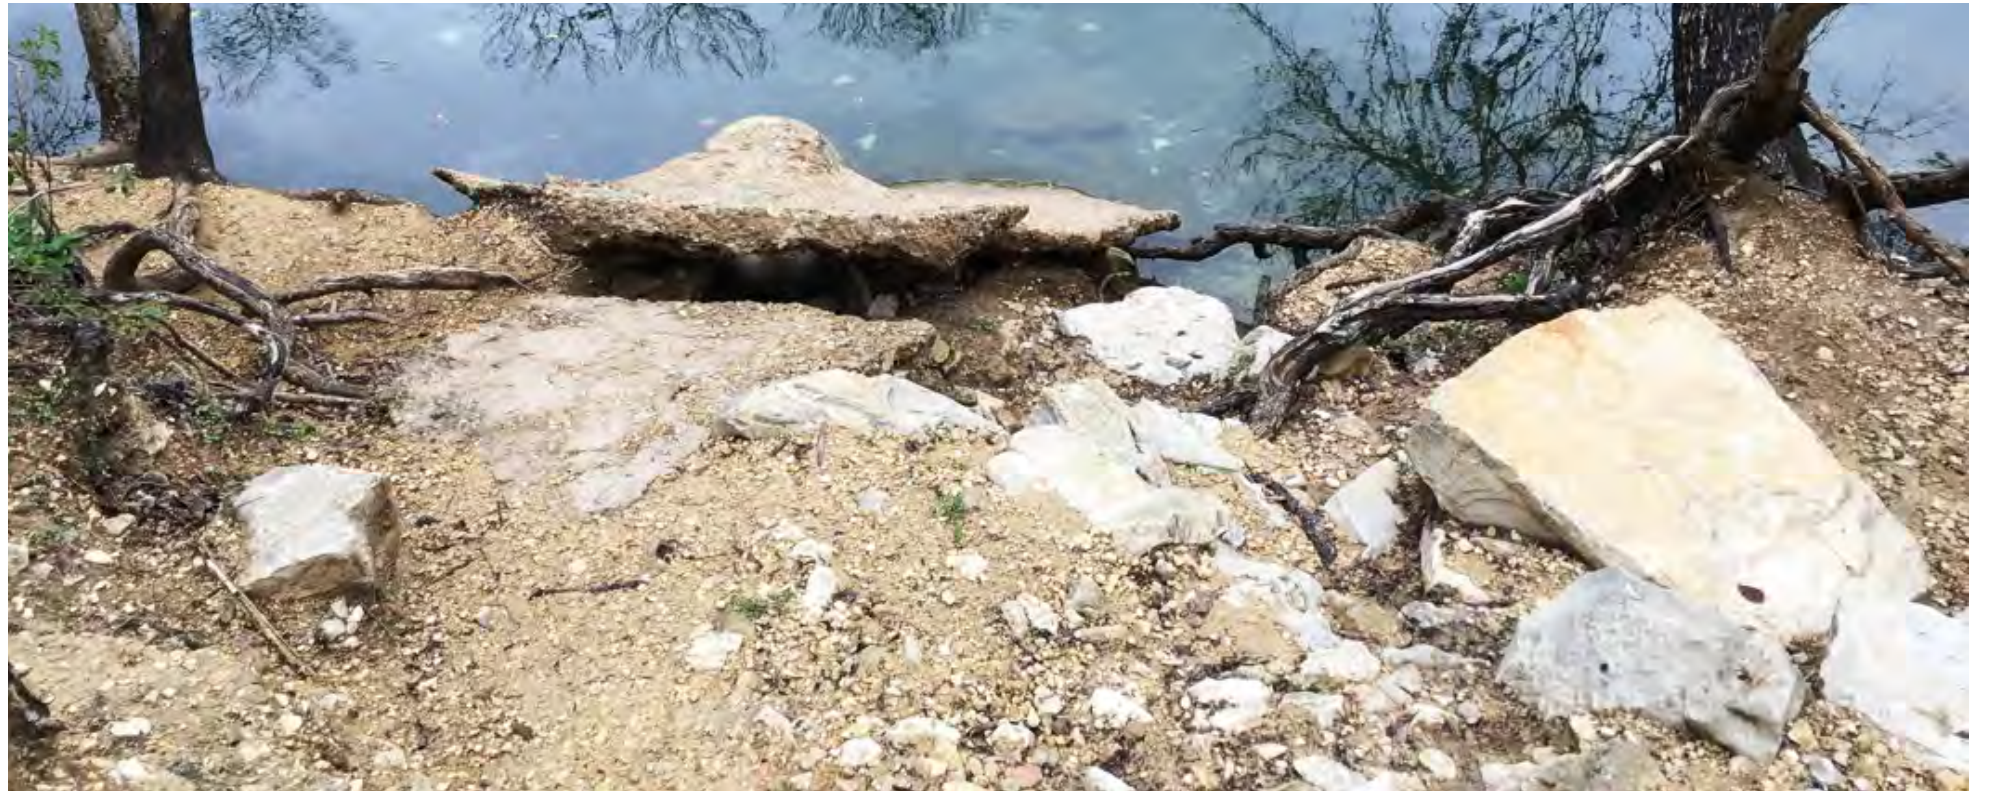
*Decomposed granite decomposition near water edge*

In some areas, decomposed granite is leaving the trail and entering either natural areas or waterways. This material can bury native plants and make the soil more susceptible to erosion, thus lowering the quality of the natural area. Deposition is occurring throughout the park but is pronounced near the Violet Crown Trailhead, on steep slopes in the Degraded Barton Riparian Woodland, and throughout much of the Butler Trail along the lake and creek.

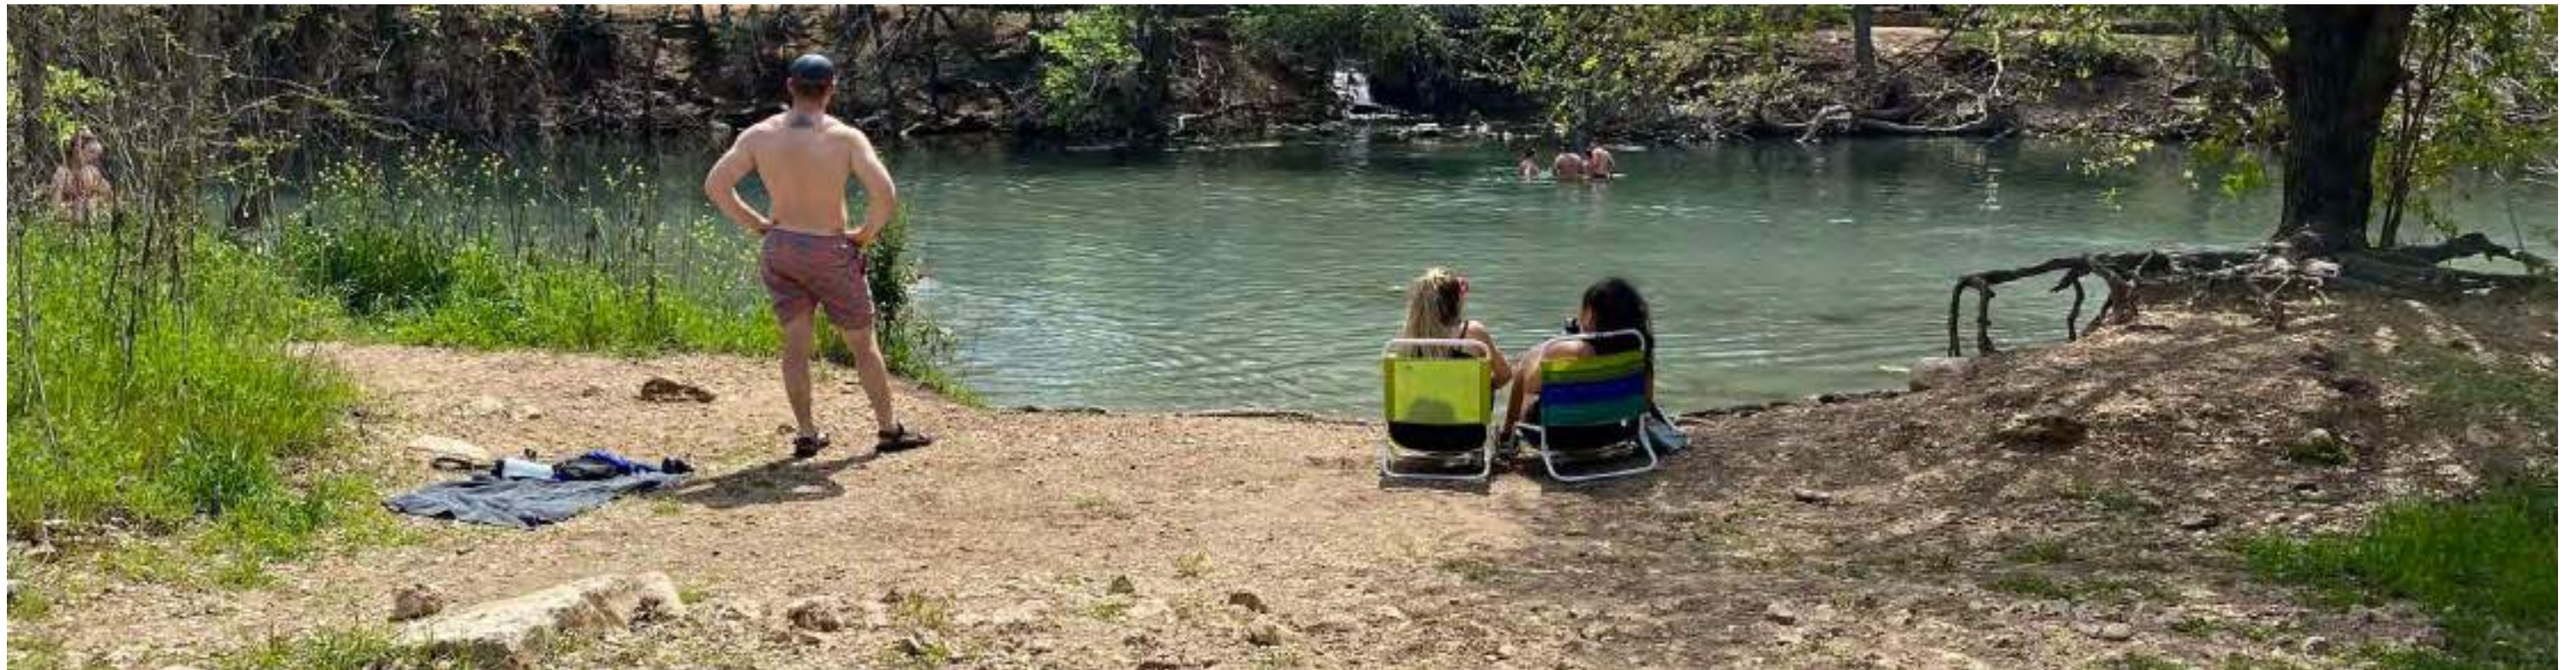
*Trampling from human traffic compacts soil and prevents plant establishment*

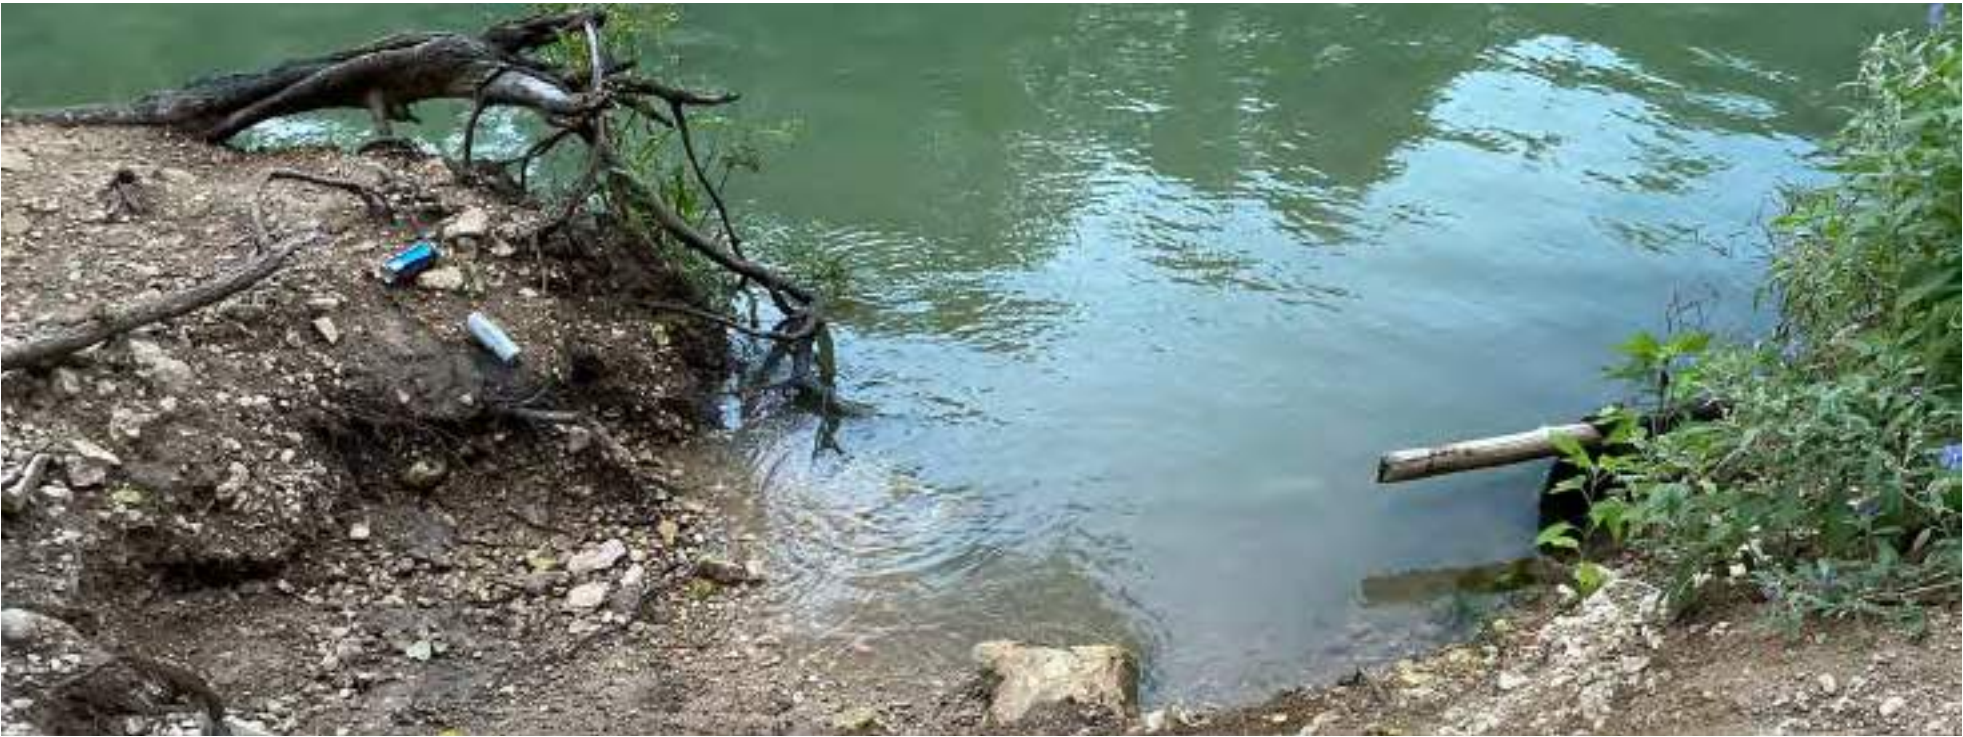
Trash and erosion along Barton Creek has been accelerated by intense foot traffic.

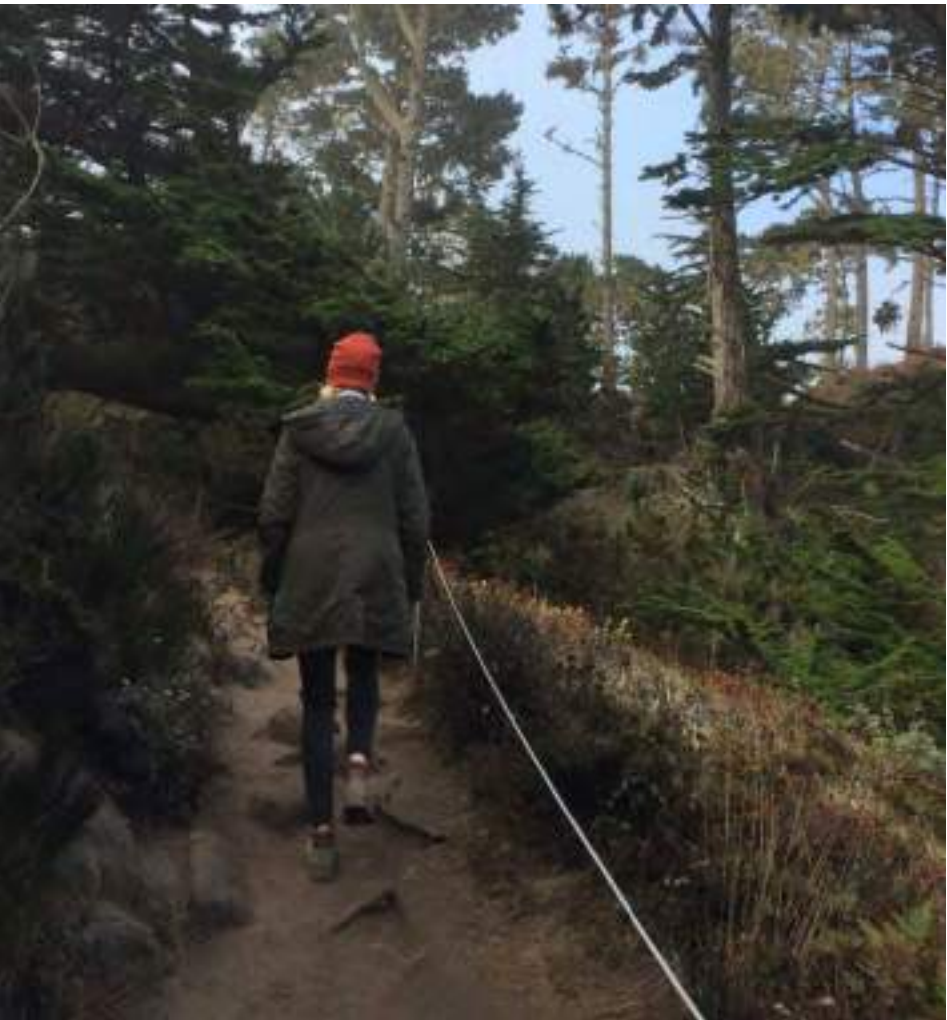
Simple, knee high fencing can discourage off trail activity.

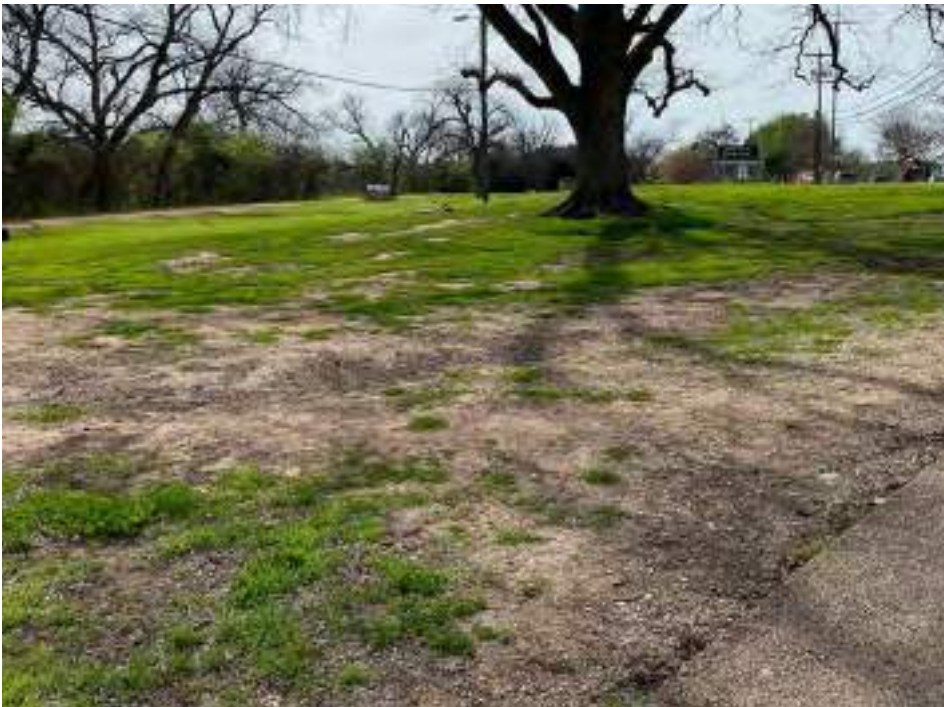
Compaction from human trampling is aggravated by stormwater runoff from impervious cover.

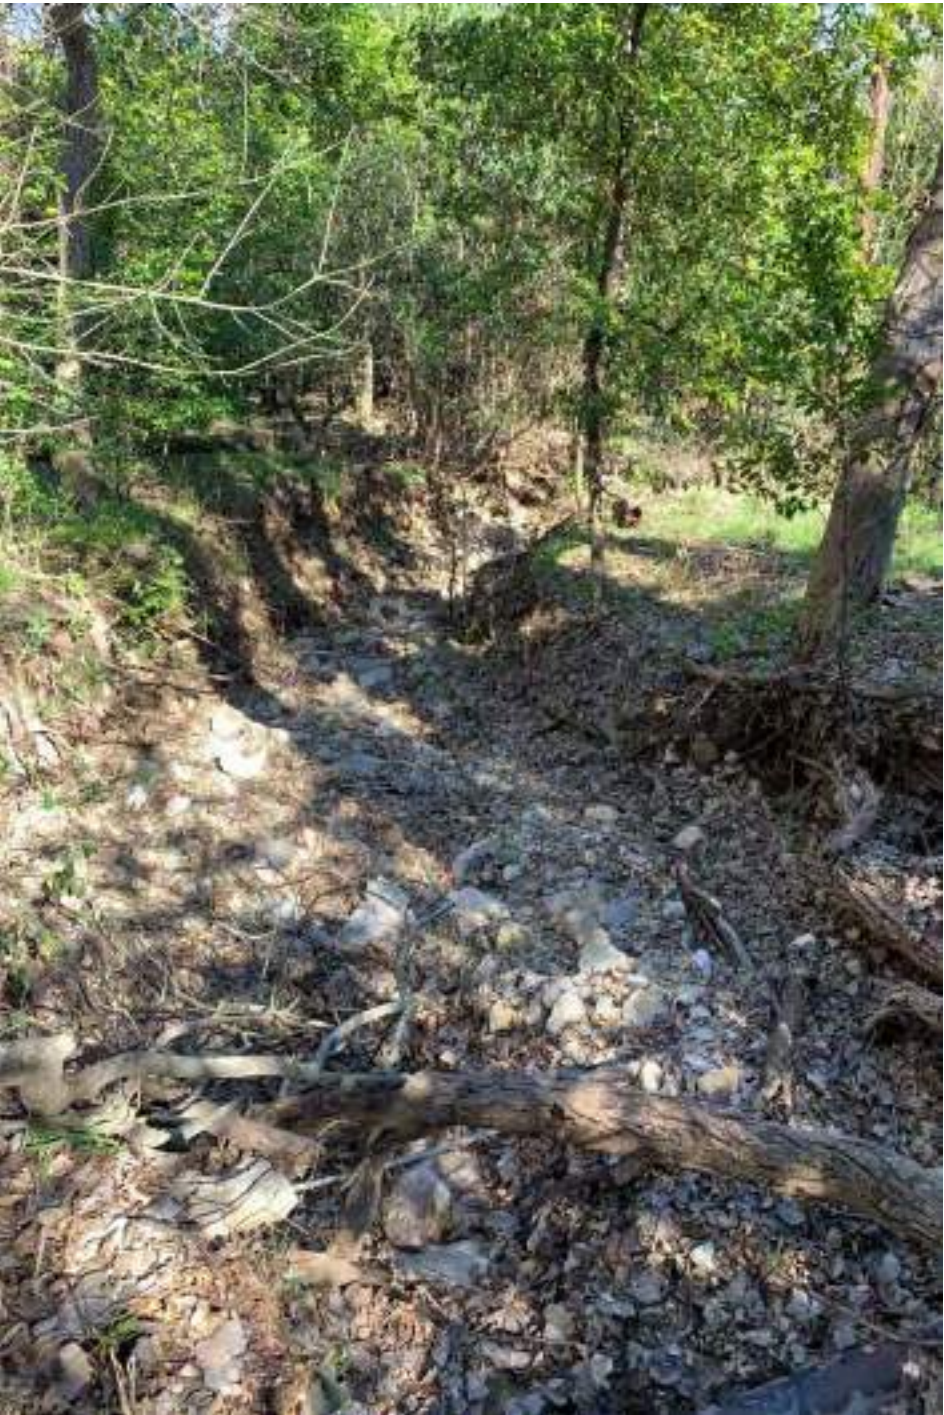
Gully erosion located between Stratford Drive and Lady Bird Lake.

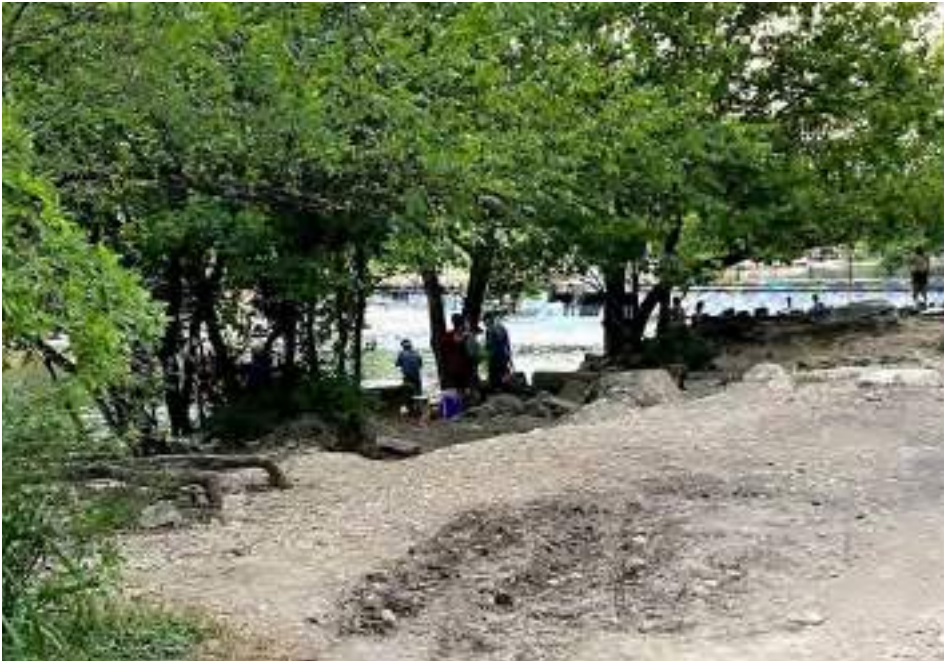
Heavy use near Bark’n Springs causes shoreline erosion

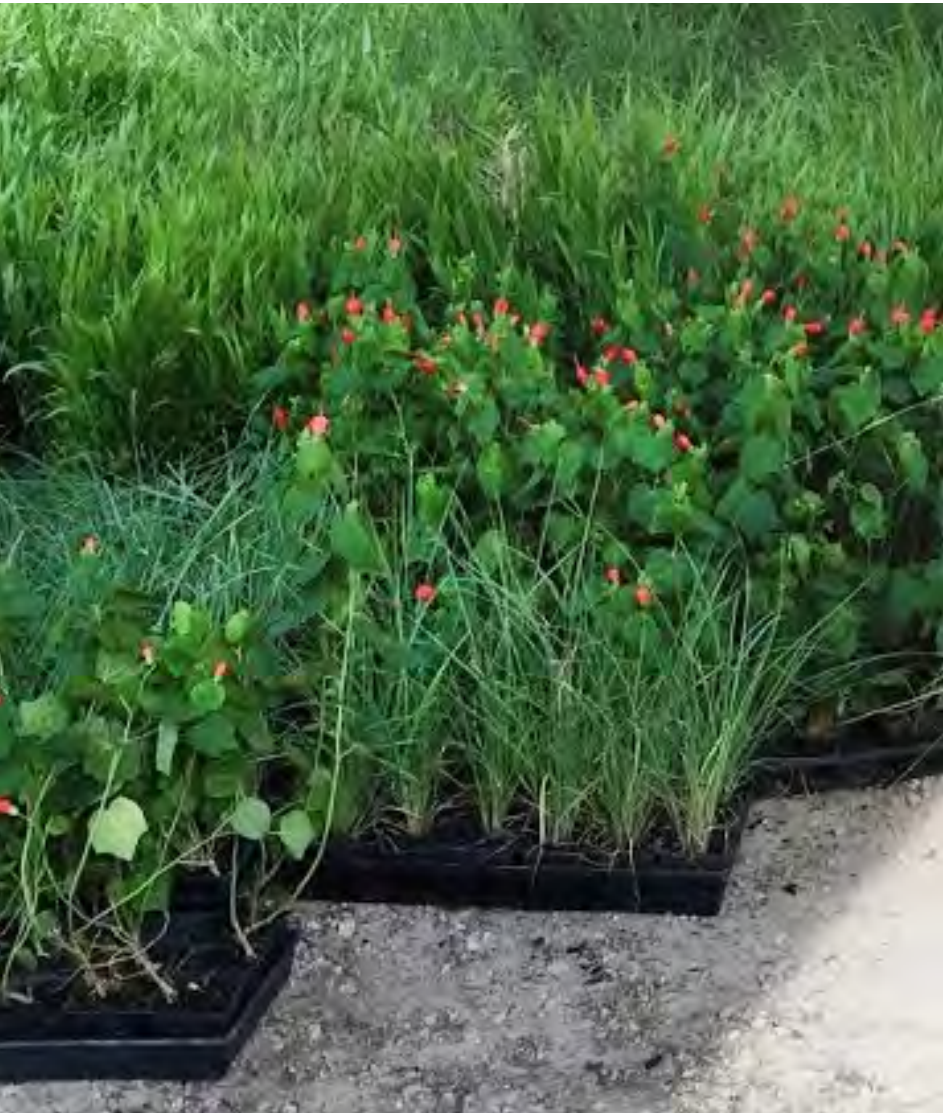
*Live plantings of understory and herbaceous material work to stabilize soils and better define the user experience. The size of plantings affect the success rate depending on the conditions of the site.*
